# Tidal salt marsh restoration at John H. Chafee NWR.

Hurricane Sandy Resiliency Coordinator, USFWS

On Pett Cove, January 29, 2017

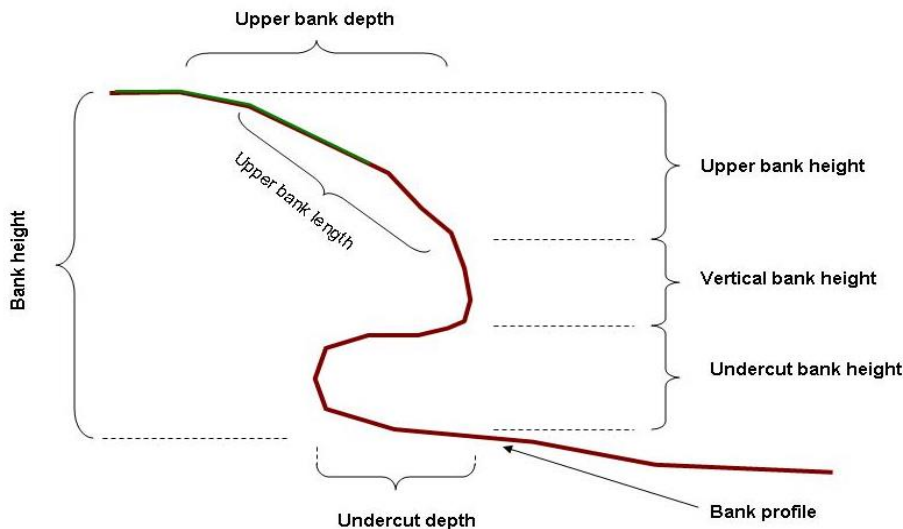
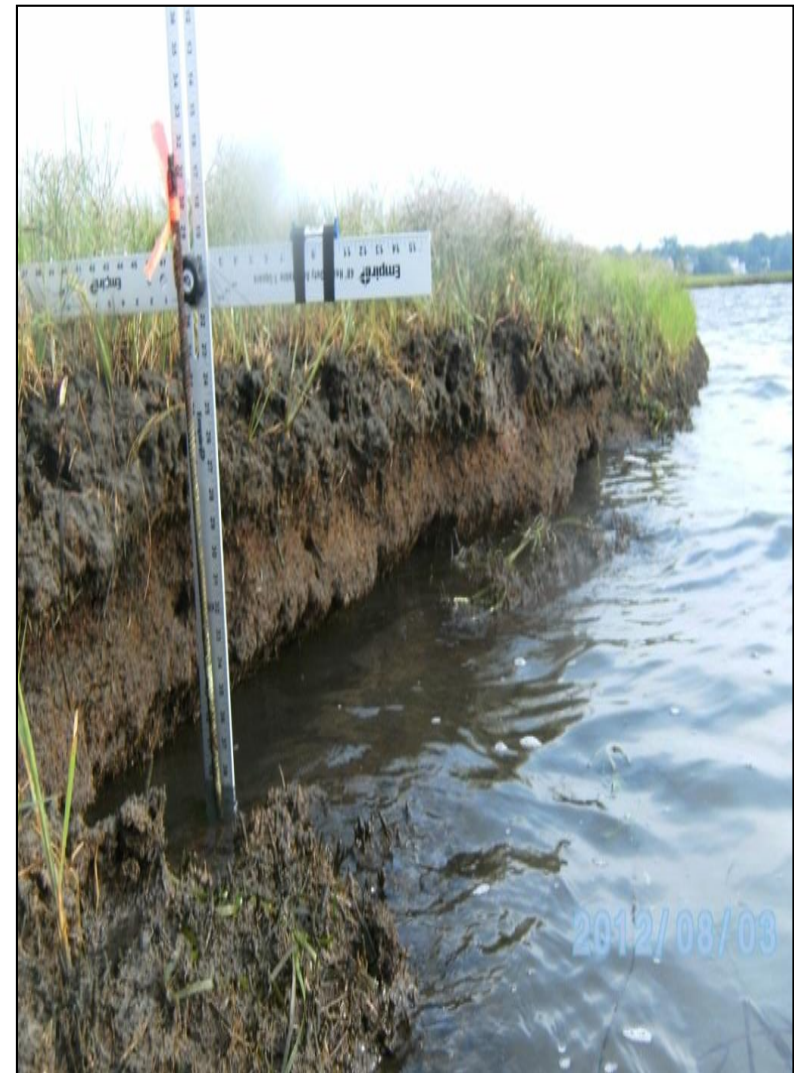
- Unstable Banks, Narrow River
  - Sections of marsh slump into river
  - Wind driven waves, boat wakes, crabs (green/fiddler)

Cross sectional view of typical saltmarsh riverbank, Lower Narrow River

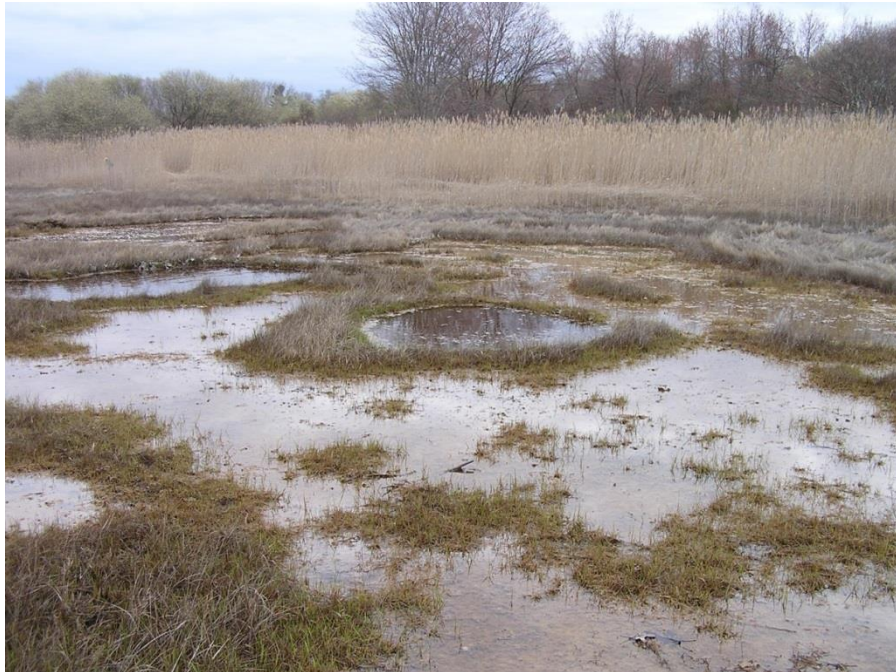
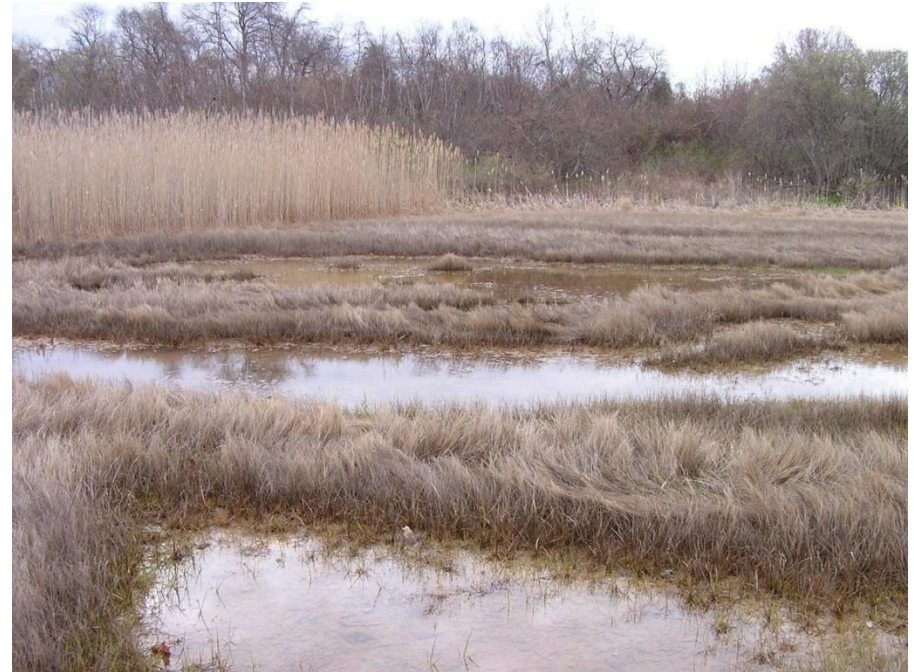
- Standing water on marsh
- Panne expansion (low plant density, stunted growth)
- Pool expansion

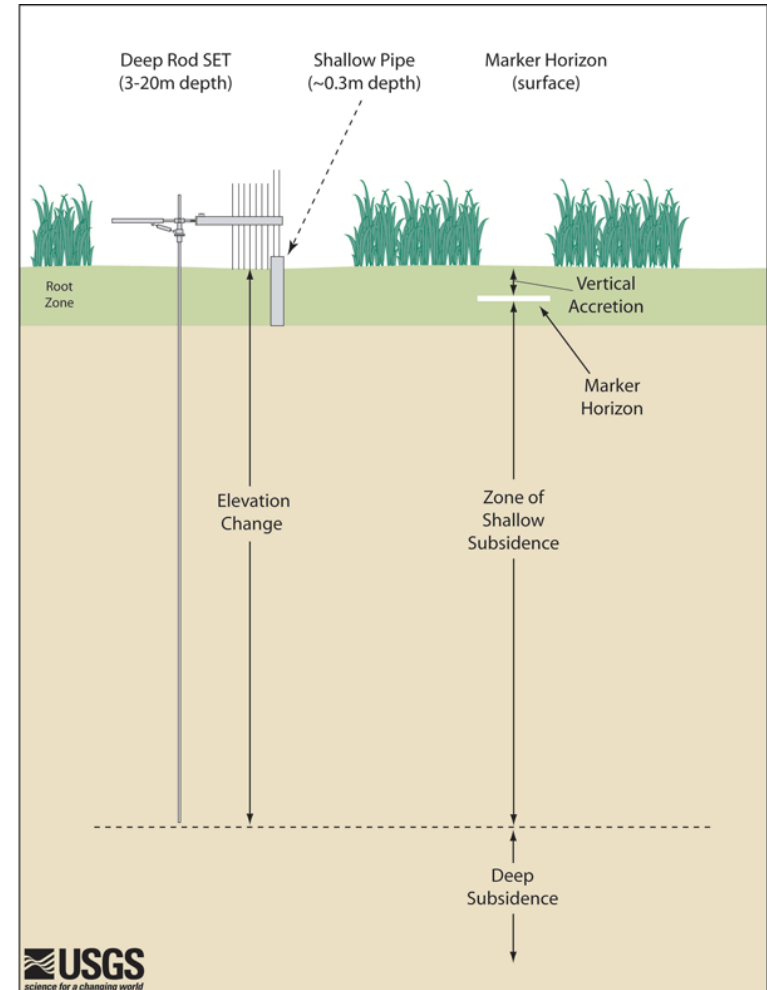
- Raposa et al. 2016.
  - Salt marsh growth = 1.83 mm/year (n = 24)
  - Sea level rise (SLR)
    - 1930 – 2015 = 2.78 mm/yr
    - 1999 – 2015 = 5.26 mm/yr

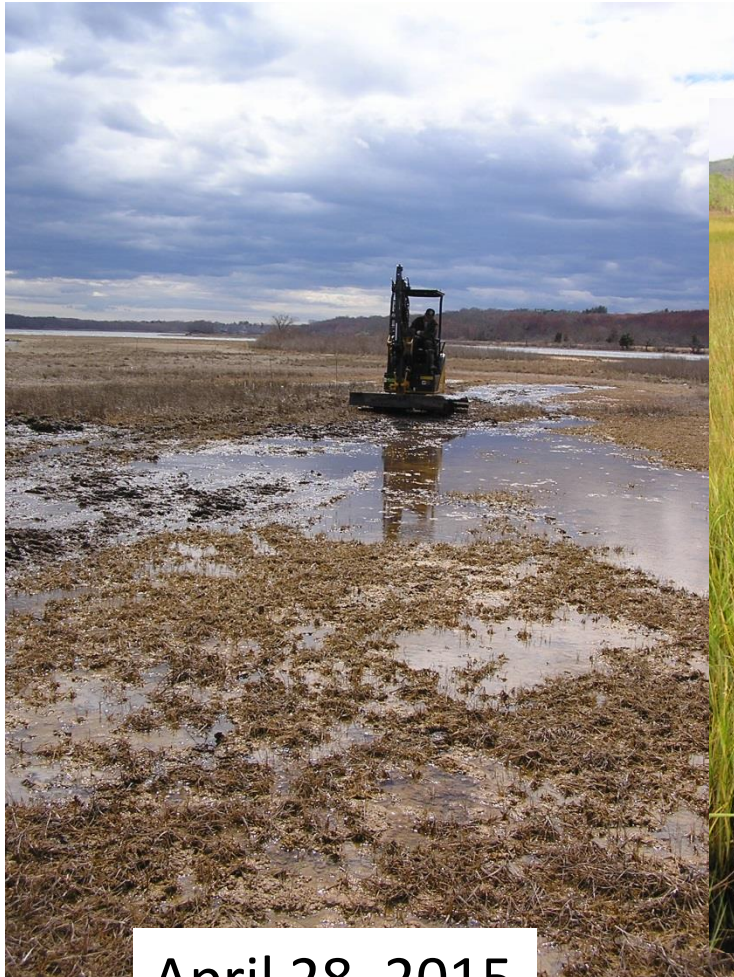
April 28, 2015

# Runnels to promote vegetation growth

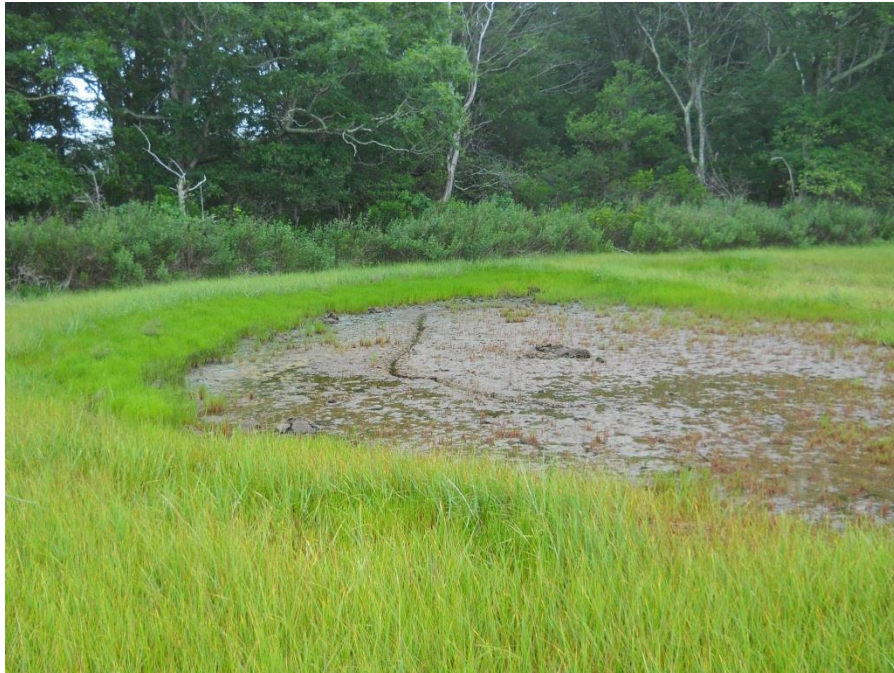
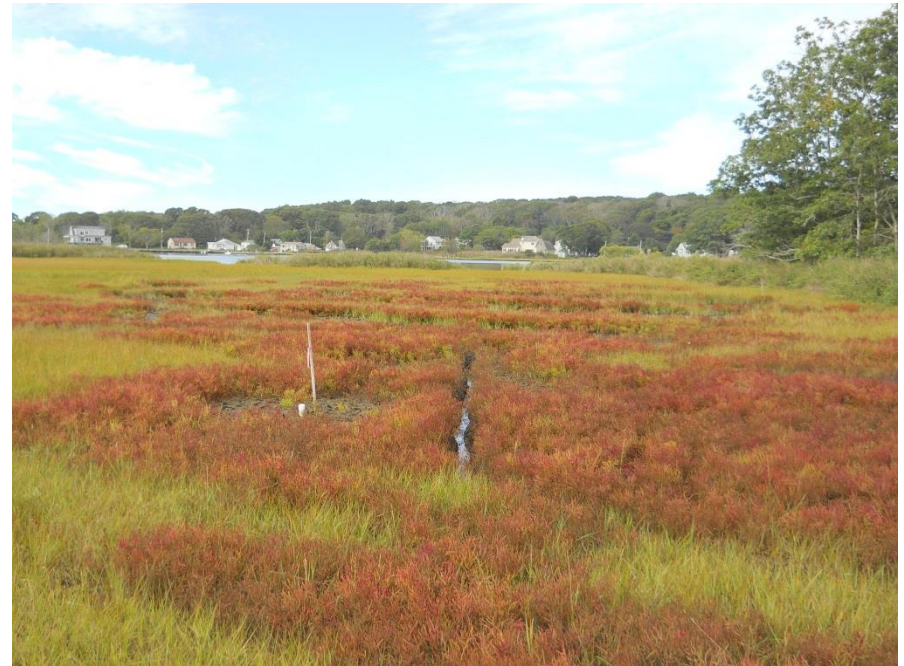
# Pickleweed (*Salicornia depressa*) colonizing bare pannes

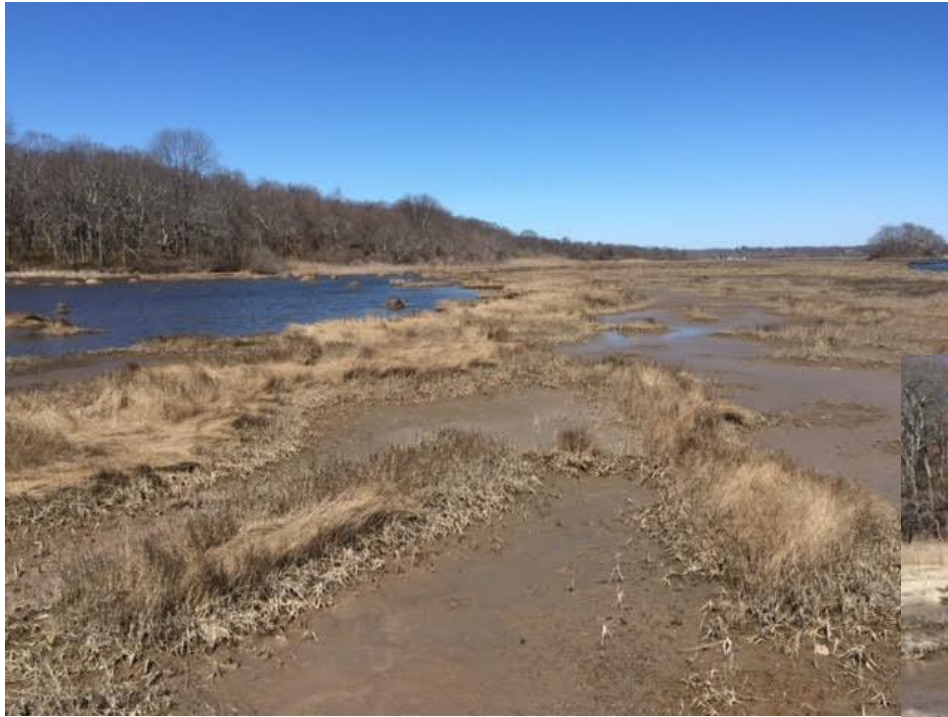
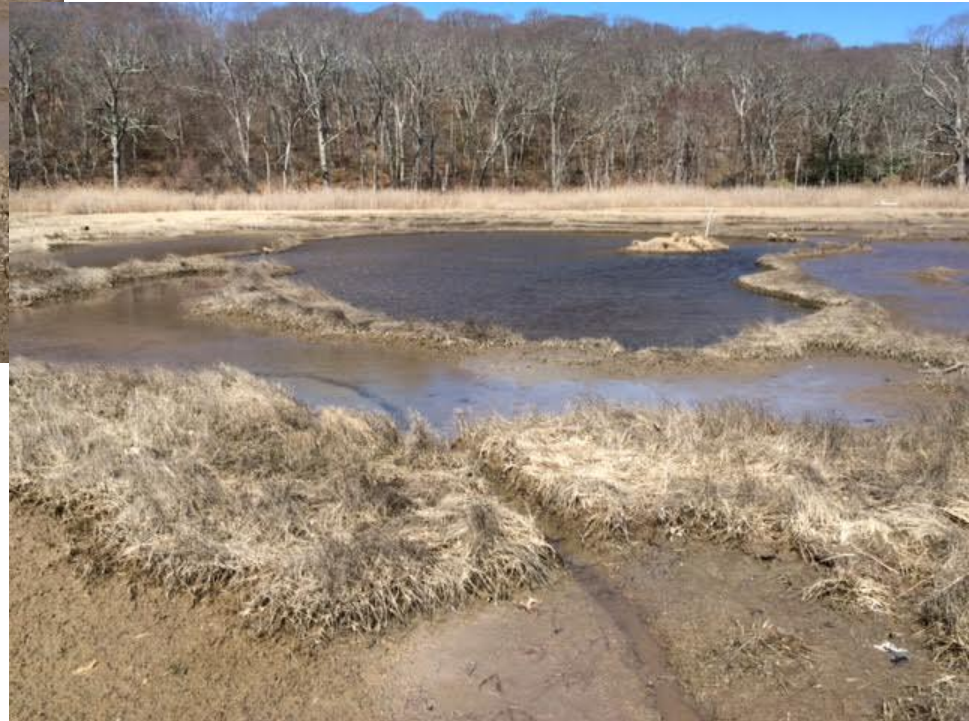
# Runnels to prevent pool expansion

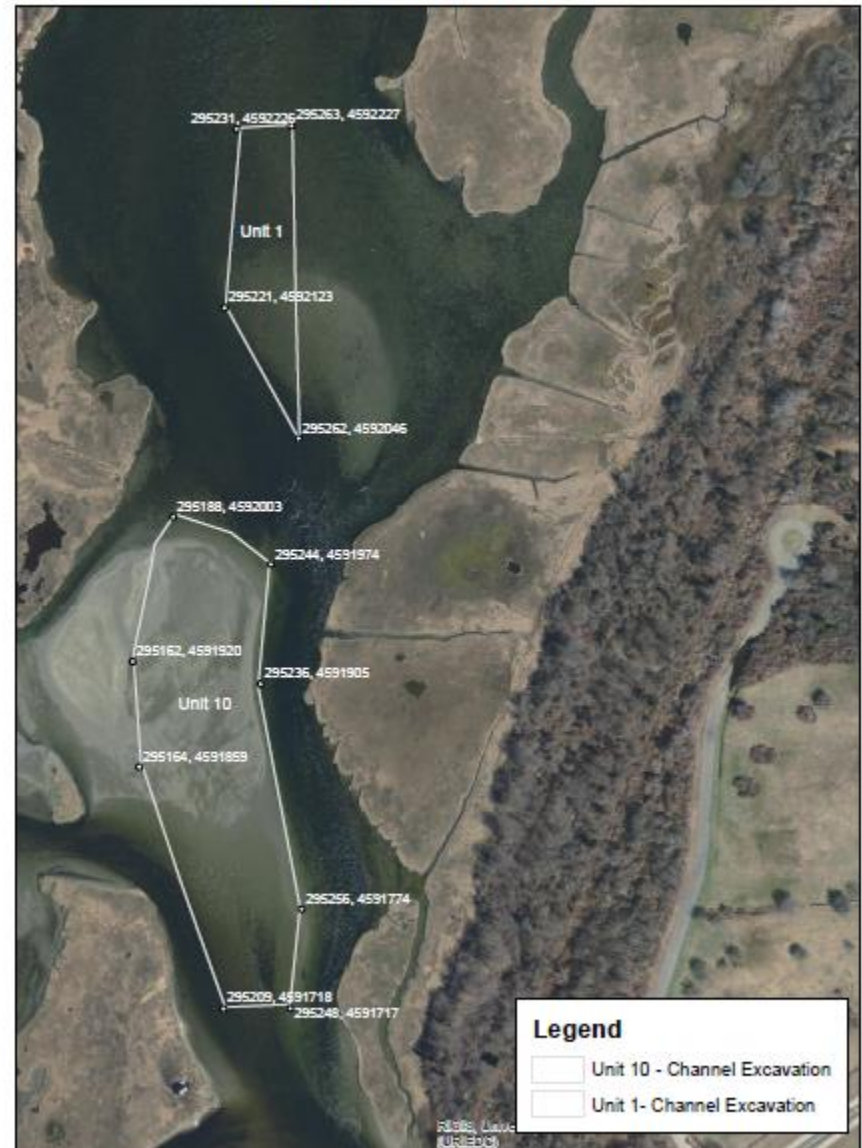
John H. Chafee NWR Resiliency Project - Narrow River  
Units 1 and 10 Coordinates

- Dredge areas
  - Create central channel for boats
  - Dredge depth, -4 ft (eelgrass, artifacts)
- Erosion control

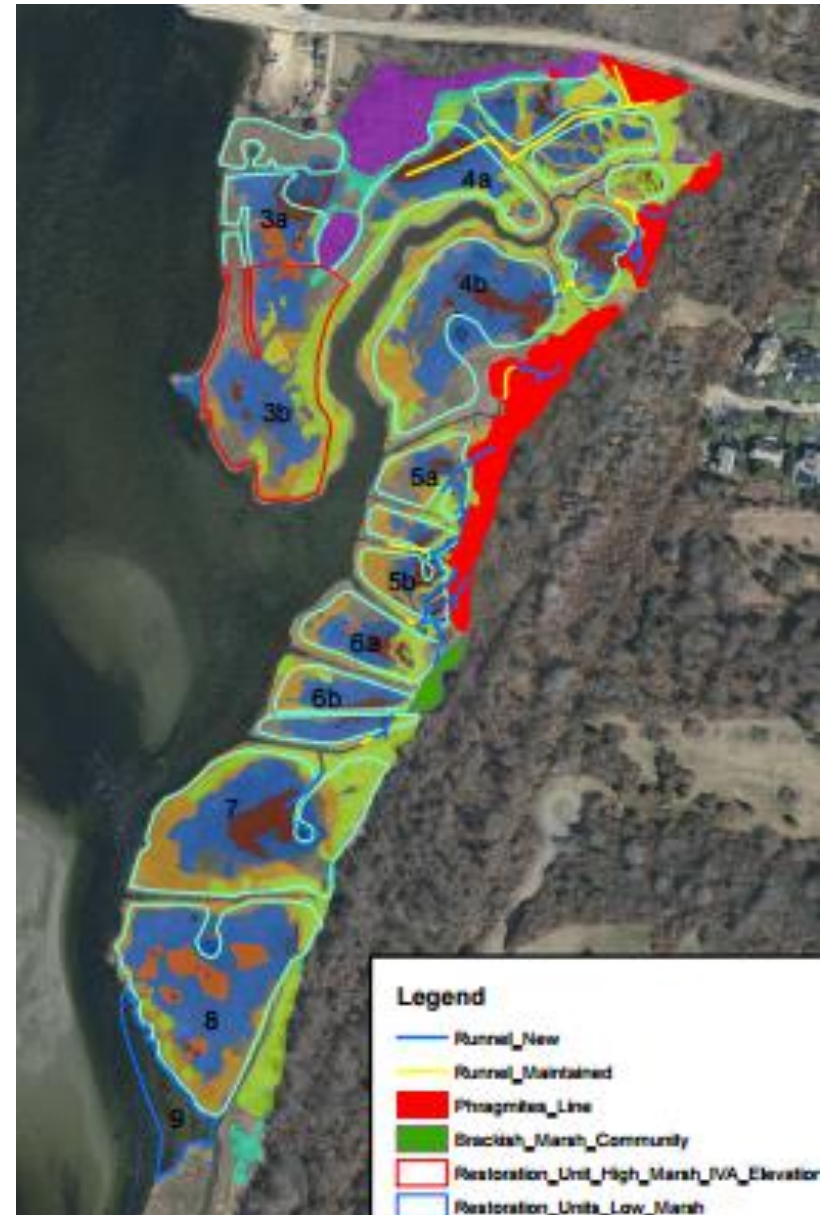
- Mapped vegetation communities
- Target elevation
- Marsh plain slope
  - 1 - 3% high marsh
  - 10 - 30% low marsh

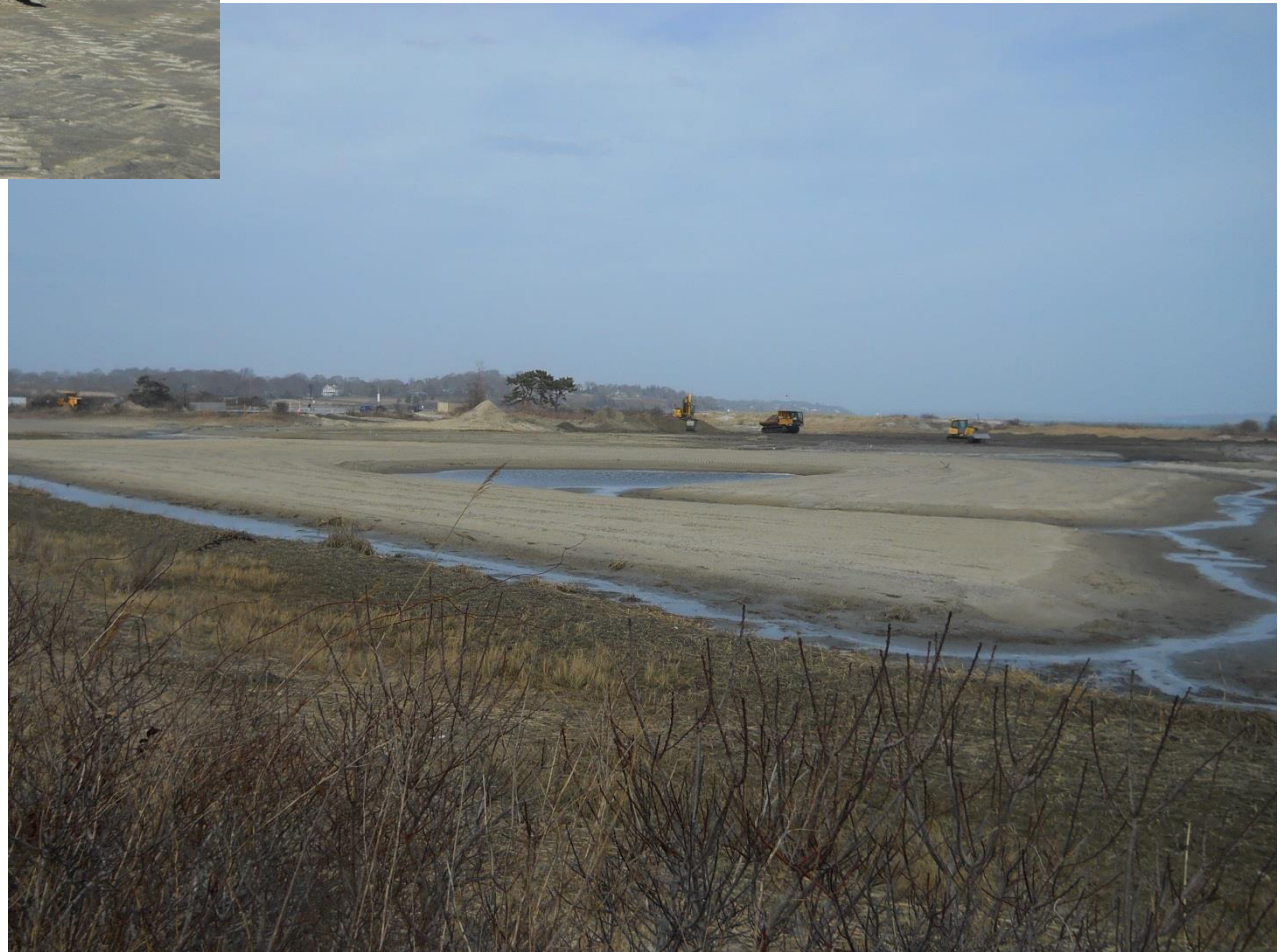
# Bulldozer that can read CAD files

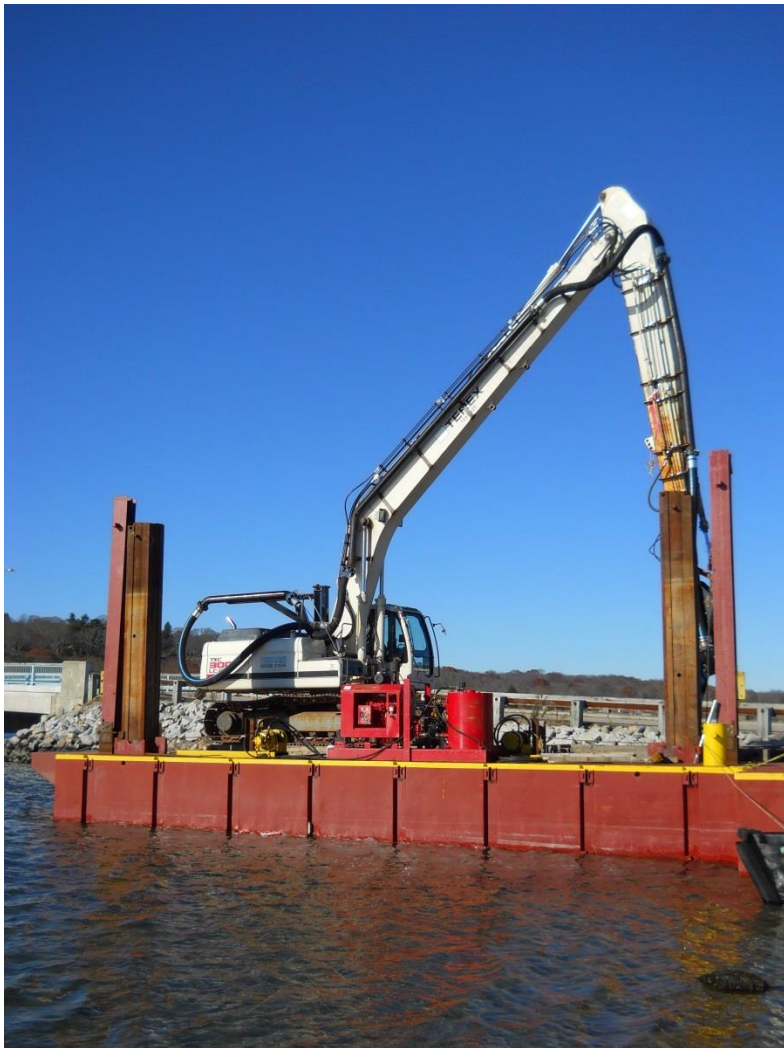
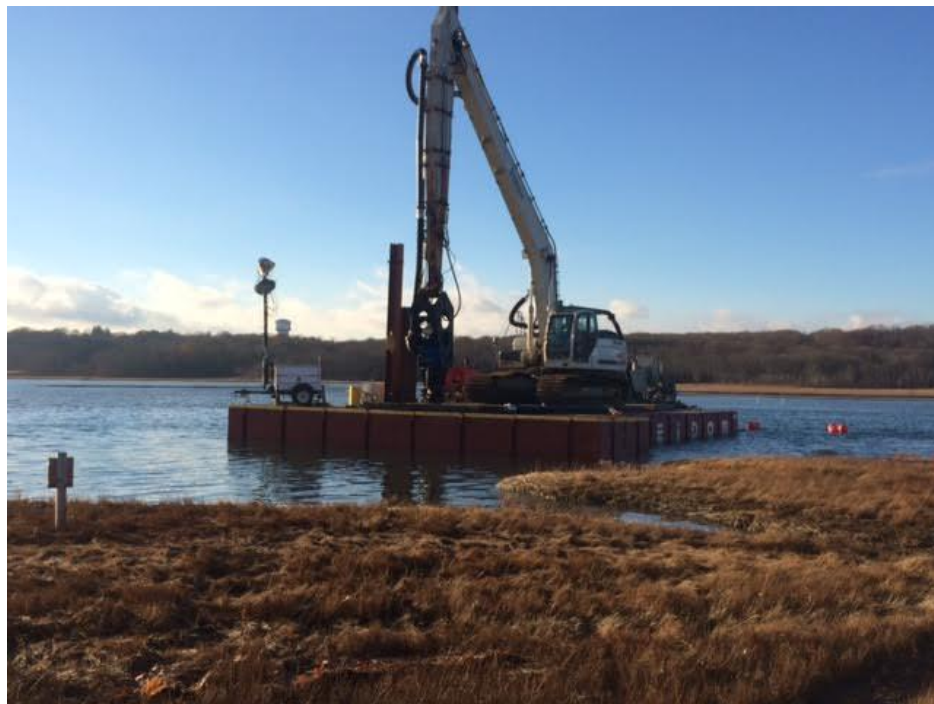
- Vertical dredge
  - Small
  - Higher % solids (40% JHC)

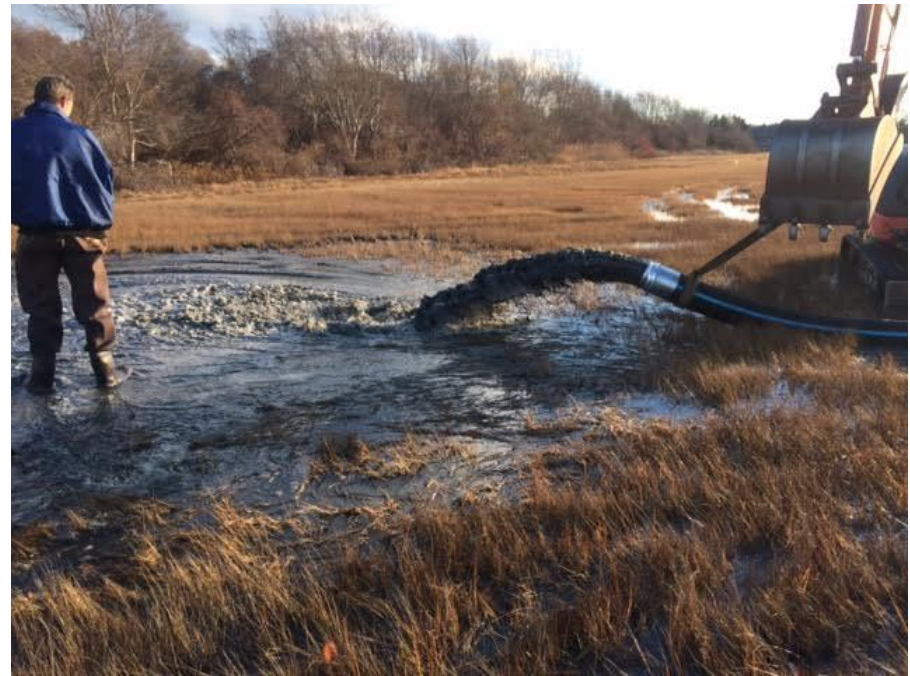
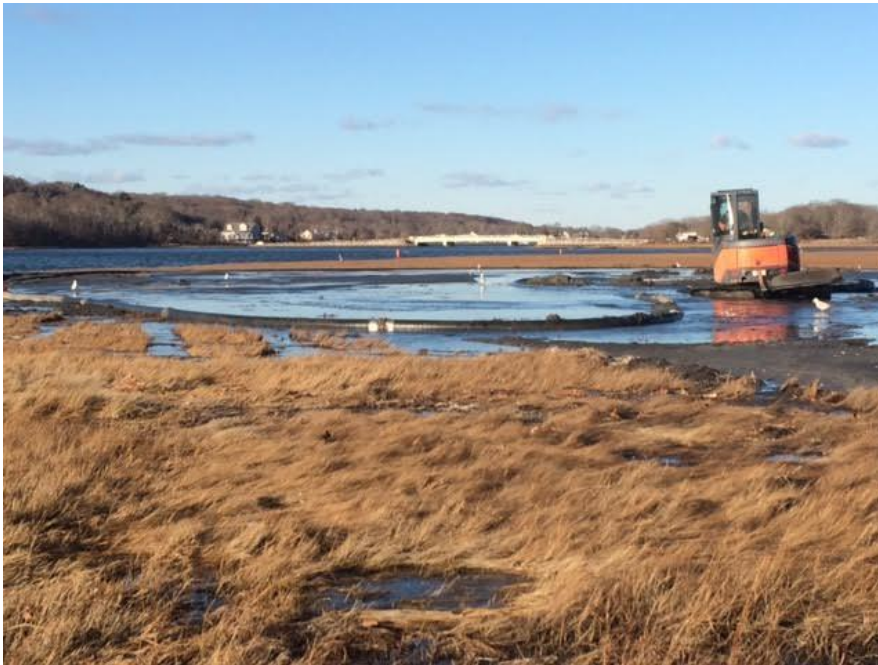
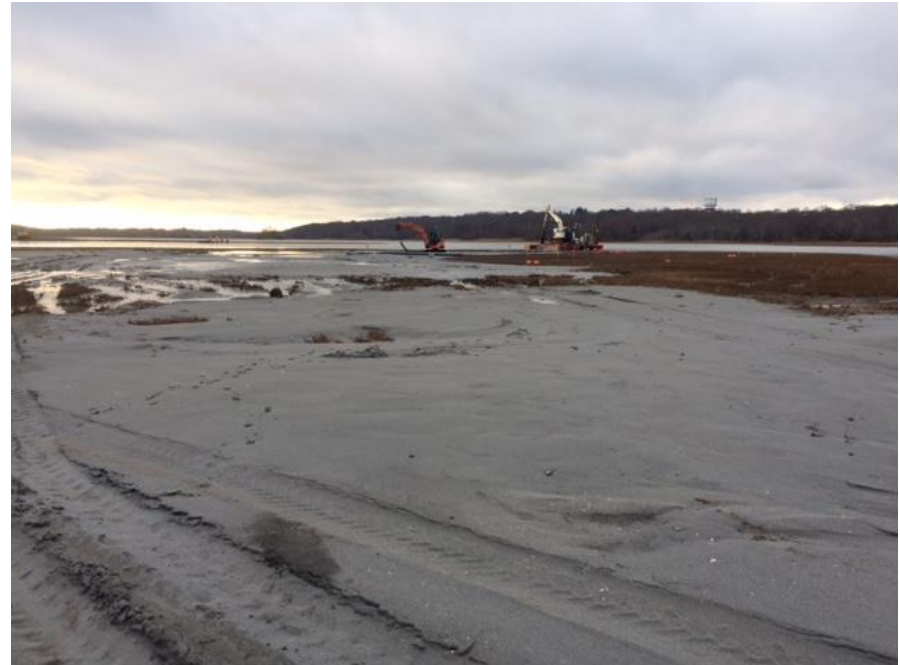
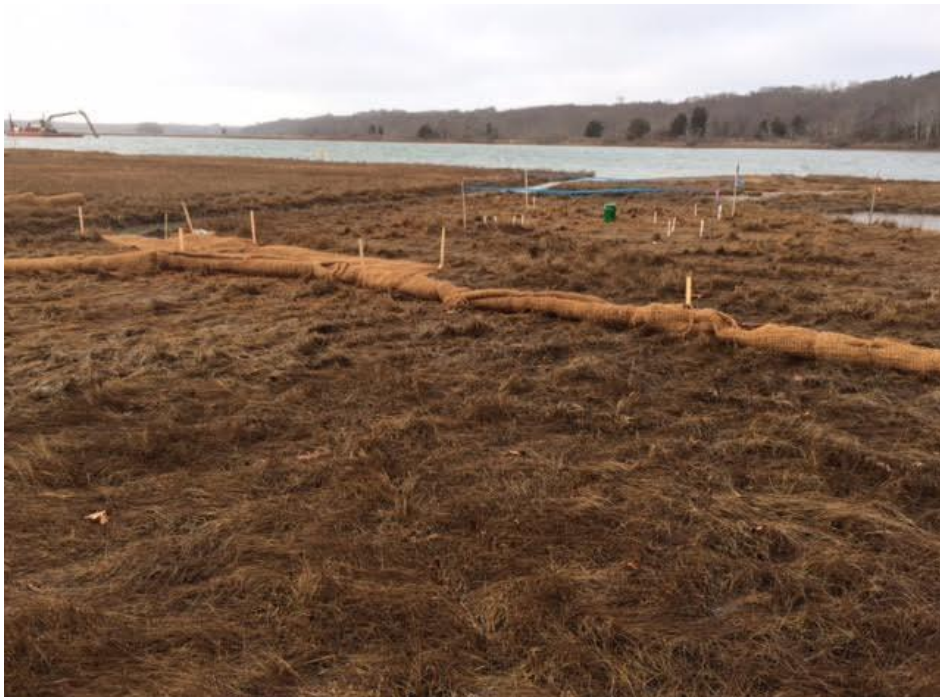
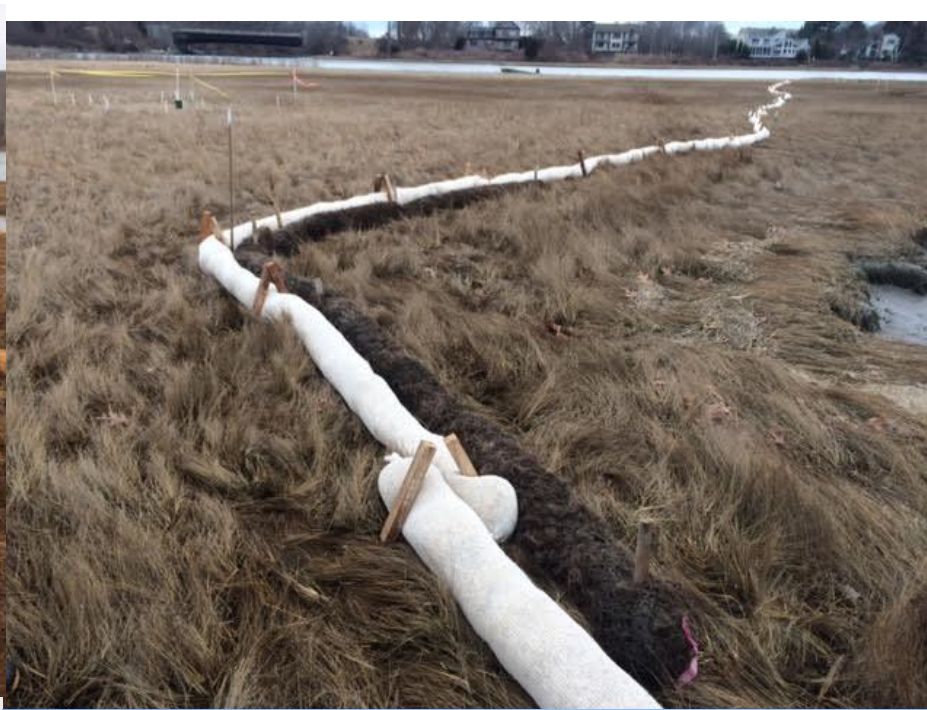
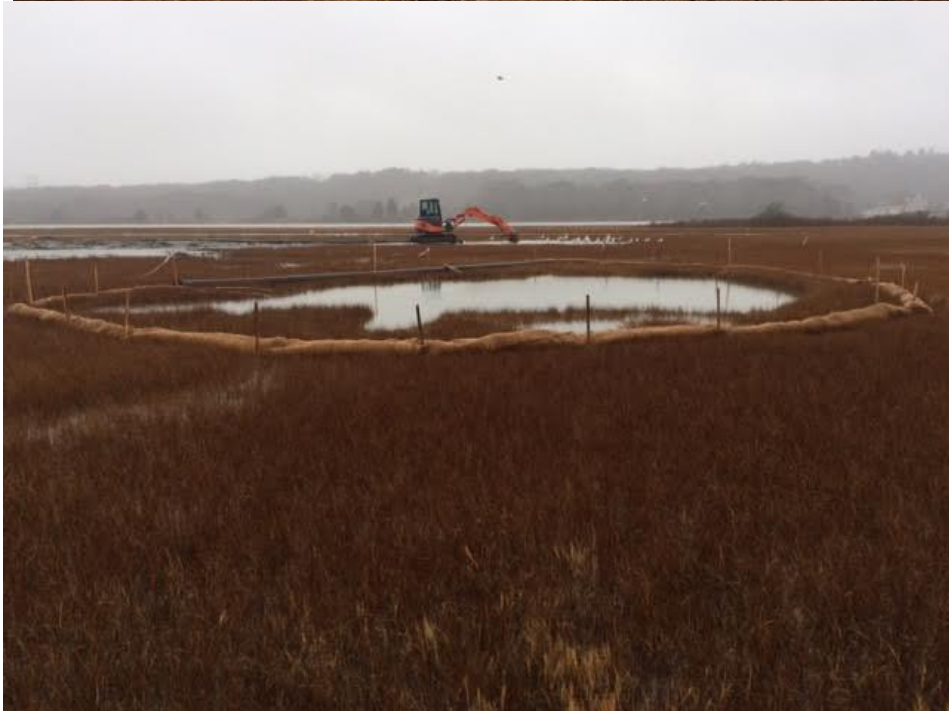
- Pipe, material stockpiled
- Rough spread (de-water)
- Contoured this March

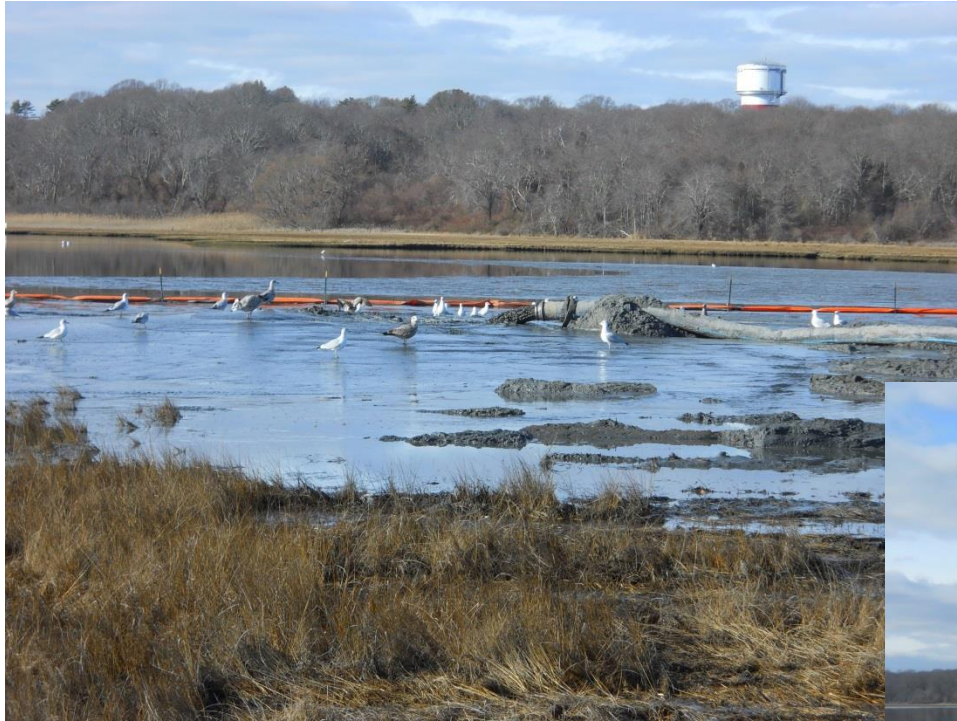
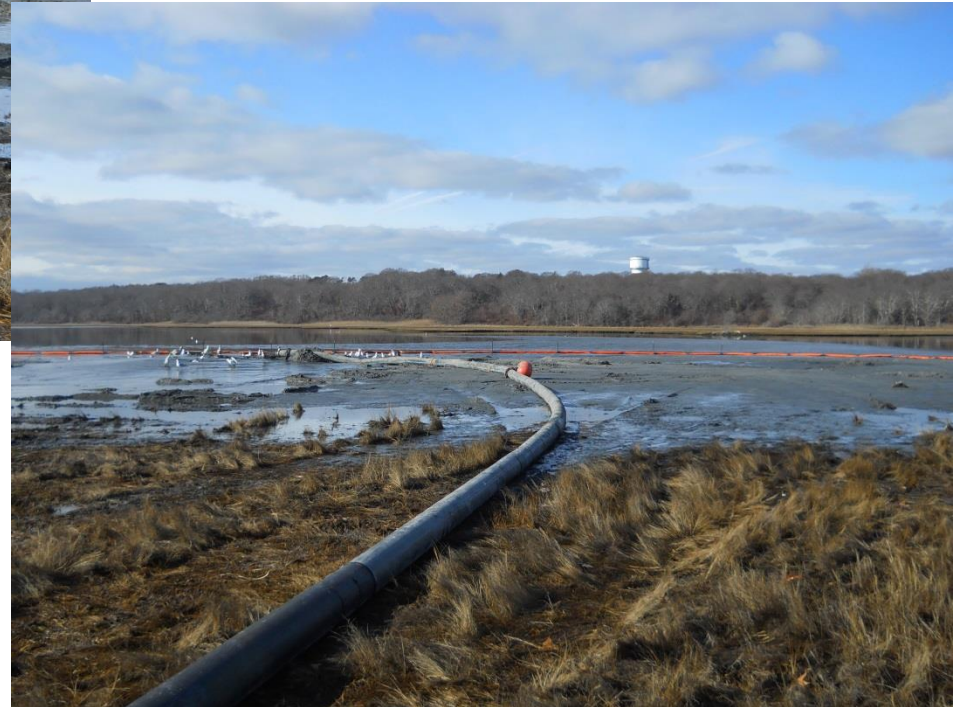
# Low marsh creation

- Containment
  - Silt fence
  - Shell bags
